CRADLE & VIAL

Tooling Modifications

Analysis and Recommendations

September 22, 2003

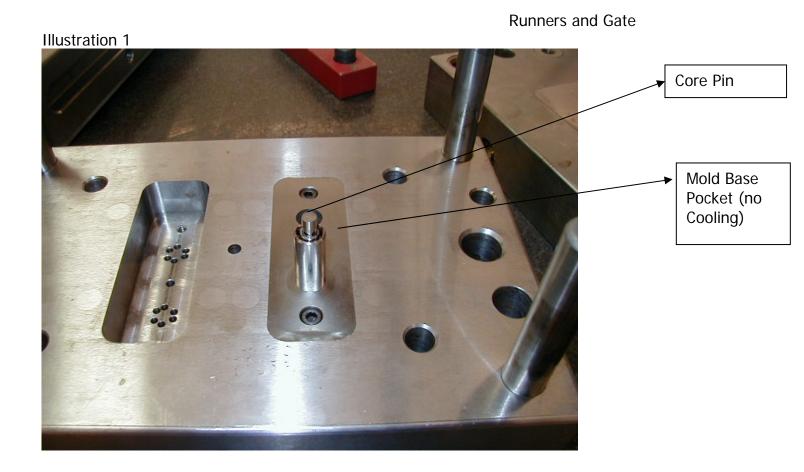
Illustration 2

Bob Allen, project engineer at Inland Technologies reiterated his concerns regarding molding difficulties in terms of using maximum pressure and mold temperature to mold these parts. Mold was taken apart and each component was analyzed. In order to improve mold filling by reducing injection pressure, we decided to enlarge the gate by 50 percent, improve venting and open up the runner system to reduce pressure drop through the gate. If the maximum plastic pressure available from the machine is 20,000 psi and if the plastic pressure required to fill the cavity is 6000 psi (not unusual for a thin walled part), the pressure loss from the machine nozzle, sprue, runner system and gate cannot exceed 14,000 psi. Therefore, reducing the pressure loss through the runner system and gate makes logical sense (illustration 1). It is guite possible that by reducing injection pressure required to fill the part, we may be able to lower the mold temperature. This should help the part mushrooming situation since the part will be sufficiently cooled to allow ejection at lower pressure. However, a more permanent solution is to find a way to provide better cooling in the core pin. Since it is not feasible to add water in the core pin, the suggestion is made to make the core pin out of highly thermally conductive material such as Ampcoloy®. These copper alloys have six to nine times greater heat transfer than convention mold steels. However, they do exhibit lower wear characteristics. Additional recommendation includes enlarging the mold base pocket (illustration 2) to accommodate a larger insert with waterlines to enhance heat transfer between Ampcoloy® core pin and insert. Also under consideration is application of Poly-Ond®

Current	Proposed
Sprue Diameter	.250	.250
Primary Runner Diameter	.156	.200
Secondary Runner Diameter	.141	.175
Gate	.030	.045
Core pin Material	Steel	Ampcoloy
Core pin Plating	None	Poly-Ond

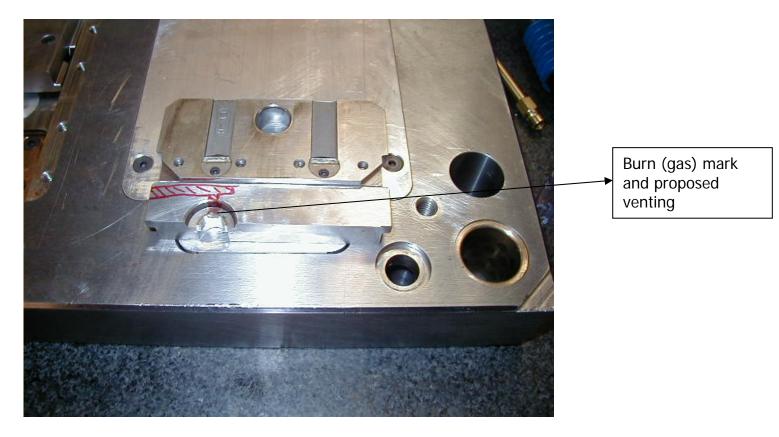
Illustration 3

A close examination of the insert shows a slight burning (indicated by black mark) indicating gas trap or inadequate venting situation. Tooling will be modified to improve venting as shown in the illustration 3.
