GRIPPER

Tooling Modifications

Analysis and Recommendations

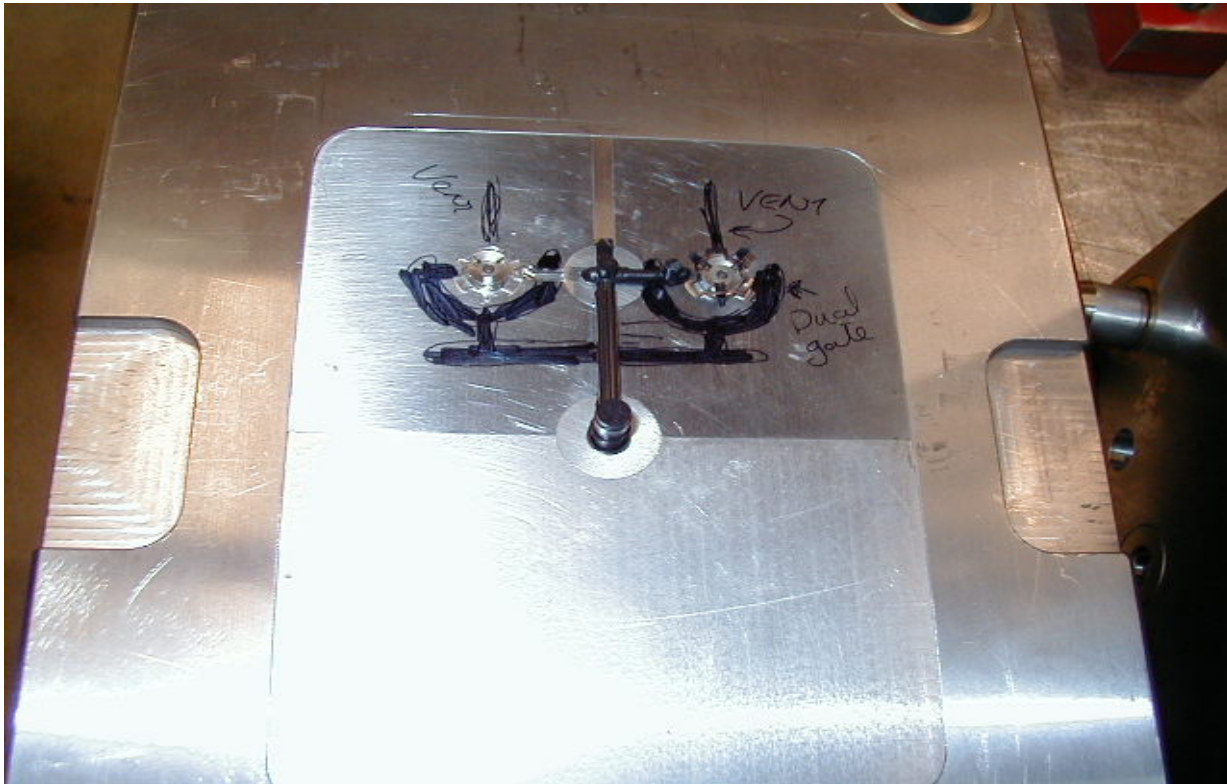
Illustration 1

Molded parts and each major component of the mold were carefully evaluated and scrutinized. This lead to determination and conclusion that in order to mold flash free parts the tooling components must be remanufactured and match-burned or match-EDM (A technique where the steel is used as an electrode when burning mating halves together to achieve matched fit). A short shot is occurring consistently at the one of the Gripper legs situated the farthest form the gate location of the part. Material has to travel further to fill this area and it appears to be contributing to the short shot problem. Also, there are no vents at the parting line to remove the air and volatiles. A decision is made to recut the runner, add a second gate positioned 180° apart (Illustration 1) and add vents at parting line.

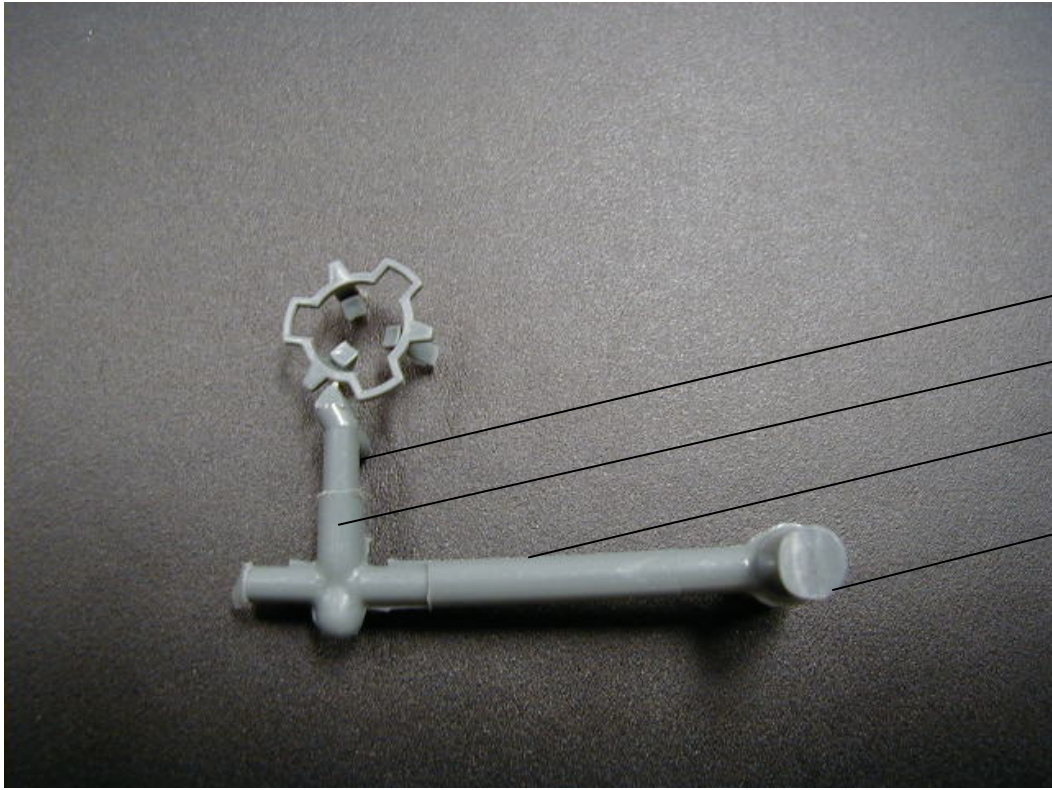
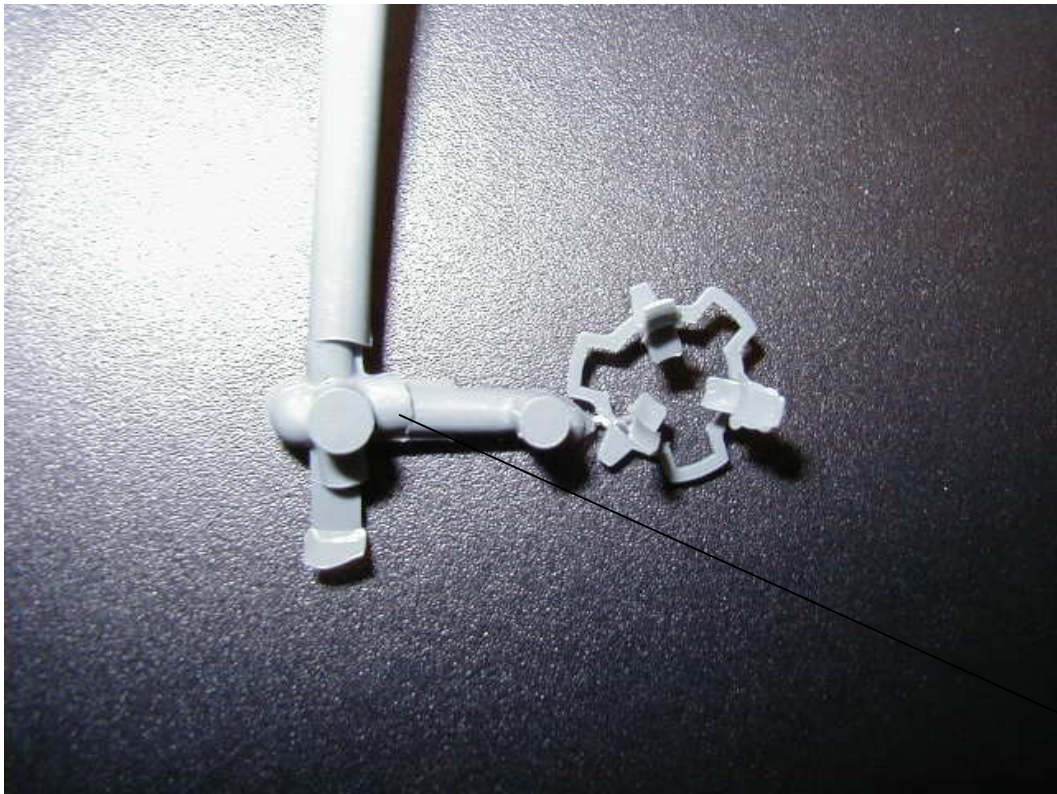
Illustration 2

As the material flows from the sprue to the primary runner to the secondary runner and tertiary runner and so on, the pressure drops at every transition. This pressure drop also creates a drop in velocity of the material racing through the runner channels at every transition. In order to maintain constant velocity and temperatures throughout the runner system, the diameter of the secondary and subsequent runner branches are reduced. However, if the diameters of subsequent runners are reduced too much, it also creates imbalance condition. Many rules and strategy exist for runner sizing. I most often use 0.050 reductions from sprue diameter to first runner and 0.025 reductions every drop there after. In the current configuration there is also a step and a mismatch (Illustration 2), which should be eliminated.

Injection pressure required to fill this part is around 1200 psi. In order to reduce flashing and over packing and stresses that result from over packing it is desirable to reduce the pressures to the lowest level possible. Gate diameter of the current design is .015, which I believe is too small and restrictive. It is quite possible that the gate is freezing off prematurely requiring much higher pressures to fill and pack the parts. I recommend opening up the gate to .029 (width and depth) to improve flow.

- Step
- Secondary
- Primary
- Sprue

Mismatch

Current	Proposed
Sprue Diameter	.250	.250
Primary Runner Diameter	.156	.200
Secondary Runner Diameter	.140	.175
Step	.125	No Step
Gate size (Width & depth)	.015 X .025	.029 X .029
Gate	Single	Dual
Vent @ P/L	None	Add

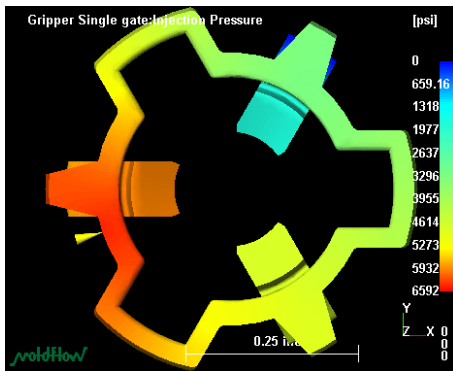
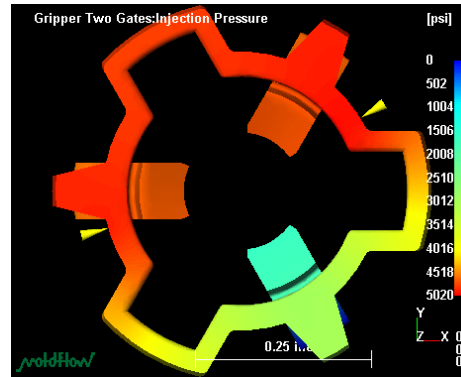
Moldflow Analysis Results (Single gate vs. Two gates)

Injection Pressure reduced by 1500 psi

Faster fill in critical area

Fill pattern changed

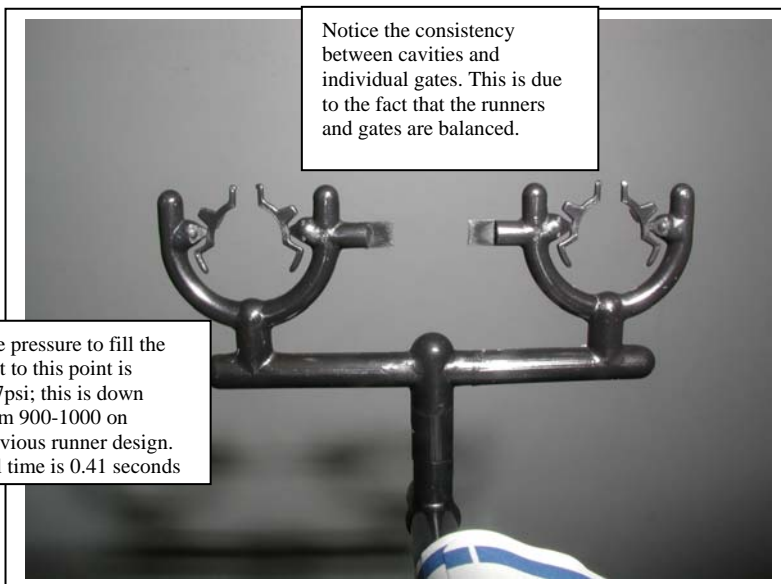
Notice that the balance is still maintained to this point of fill.

The pressure to fill the part to this point is 640psi; this is down from 900-1000 on previous runner design. Fill time is 0.42 seconds.

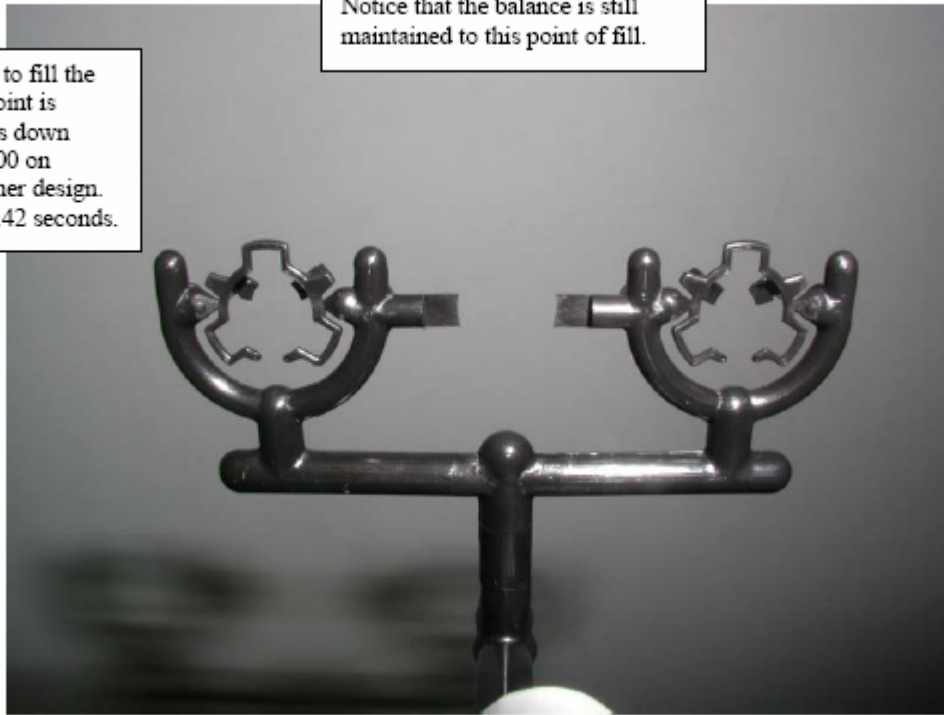
Notice that the balance is still maintained to this point of fill.

The pressure to fill the part to this point is 645psi; this is down from 900-1000 on previous runner design. Fill time is 0.43 seconds.
