CRADLE & VIAL

Tooling Modifications

Analysis and Recommendations

September 22, 2003

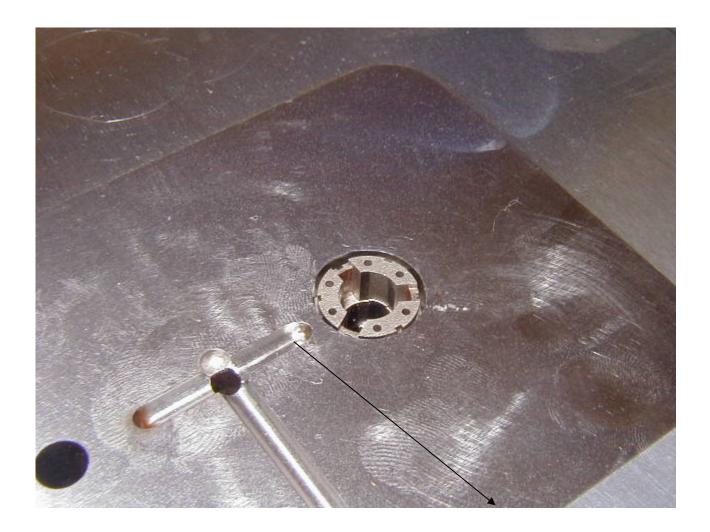
Current	Proposed
Sprue Diameter	.250	.250
Primary Runner Diameter	.156	.200
Secondary Runner Diameter	.141	.175
Gate	.030	.045
Core pin Material	Steel	Ampcoloy
Core pin Plating	None	Poly-Ond

coating (Nickel phosphorus coating impregnated with Teflon) on core surface to improve release of the part.
