GRIPPER

Tooling Modifications

Analysis and Recommendations

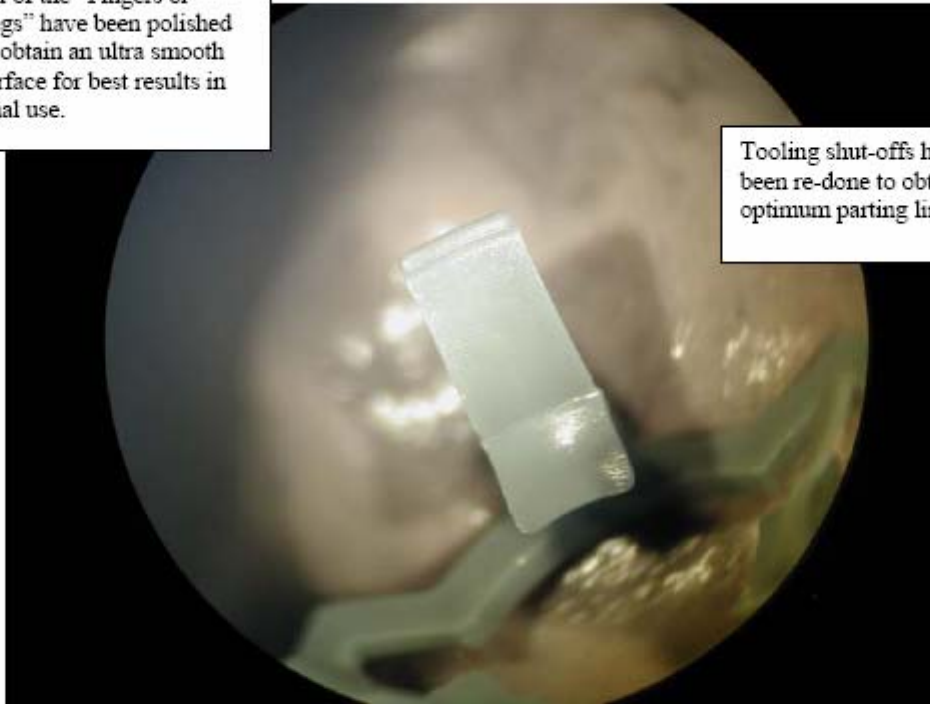
All of the "Fingers or Legs" have been polished to obtain an ultra smooth surface for best results in final use.

Tooling shut-offs have been re-done to obtain optimum parting lines
